## WELDING INSPECTION REPORT

**OSM Arrival Time:** 700 **Project Name:** SAS Superstructure **OSM Departure Time:** 1900 **Prime Contractor:** American Bridge/Fluor Enterprises, a JV

34-0006 **Bridge No: Component: OBG** segment

OBG outside assembly (OBG segment 3AE)

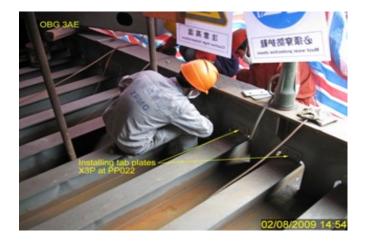
This QA observed ZPMC personnel installing tab plates identified on the detail drawings as part number X3P. These tab plates were being bolted into position @ PP022 prior to being welded in place.
